FIRST AID SAFETY BLANKET

LIFEBUOYS

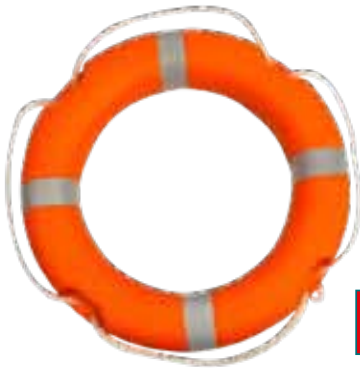
LIFEBUOYS SOLAS 74, L.S.A. CODE M.E.D., 2014/90/EU IMO MSC 81(70).

Suitable for recreational boats. Made of polyethylene and filled with polyurethane foam. With retro-reflective tapes SOLAS. Additionally approved by Transport Canada and Russian Maritime Register of Shipping.

CODE	INT. DIAMETER (cm)	EXT. DIAMETER (cm)	WEIGHT (Kg)
00557	40	60	2,5

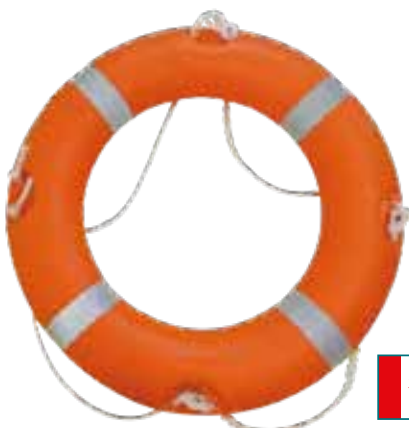
00559
00558

LIFEBUOYS SOLAS 74, L.S.A. CODE M.E.D., 2014/90/EU IMO MSC 81(70).

For commercial ships or big boats. Made of polyethylene and filled with polyurethane foam. With retroreflective tapes SOLAS. Additionally approved by Transport Canada and Russian Maritime Register of Shipping.

CODE	INT. DIAMETER (cm)	EXT. DIAMETER (cm)	WEIGHT (Kg)
00559	43,6	75	2,5
00558	43,6	75	4,0

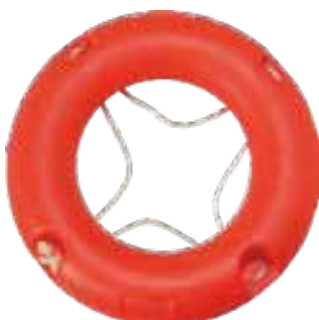
00539

RING BUOY

Made of polyethylene.

CODE	DESCRIPTION	INT. DIAM. (cm)	EXTER. DIAM. (cm)
00539*	WITHOUT FOAM / WITH ROPE	23,5	45
00539-1*	WITH FOAM / WITH ROPE / WITH REFLECTIVE TAPE.	23,5	45
00539-2*	WITH FOAM/WITH ROPE	23,5	45

* It is not an approved means of rescue
